# Streambank Erosion Estimation

City: Middleton, WI  
 Watercourse: Lake View Park Drainage Swale  
 Location ID Number: 1  
 Location: Approximately 45' Downstream of Outlet  
 Date Sampled: 5/1/2008

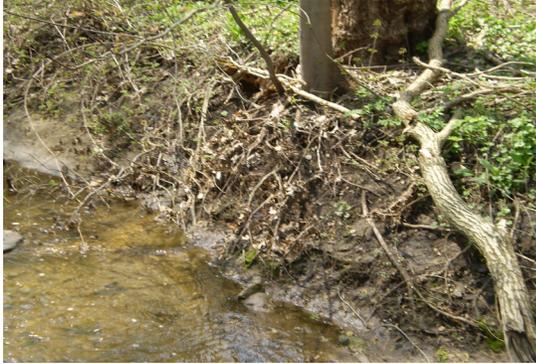
Photo of Streambank Erosion

Parameter	
Stream Side (LEFT or Right)*	RIGHT
Length (ft)	90
Height (ft)	3
Lateral Recession Rate (ft/yr)**	0.2
Soil Unit Weight (lb/ft <sup>3</sup> )	90
Soil P Concentration (lb/lb soil)	
Stream Bank Erosion (tons/yr)	2.4

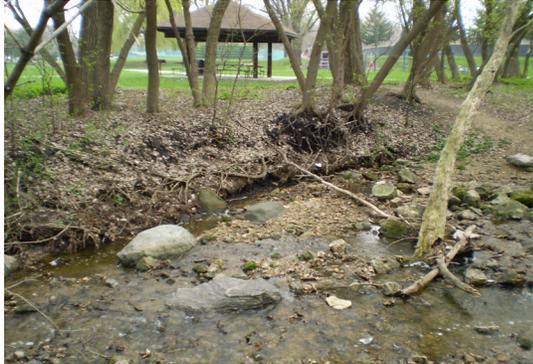
Photo of Streambank Erosion

City: Middleton, WI  
 Watercourse: Lake View Park Drainage Swale  
 Location ID Number: 2  
 Location: Approximately 40' Downstream of Outlet  
 Date Sampled: 5/1/2008

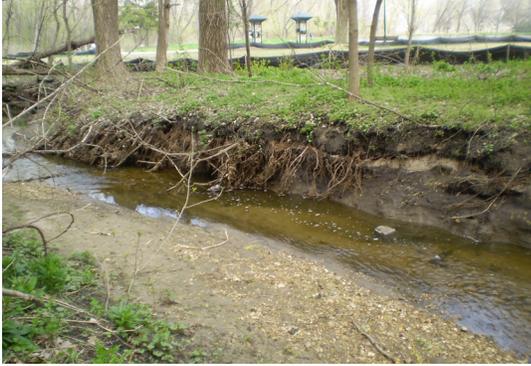
## Photo of Streambank Erosion

City: Middleton, WI  
 Watercourse: Lake View Park Drainage Swale  
 Location ID Number: 3  
 Location: Approximately 110' Downstream of Outlet  
 Date Sampled: 5/1/2008

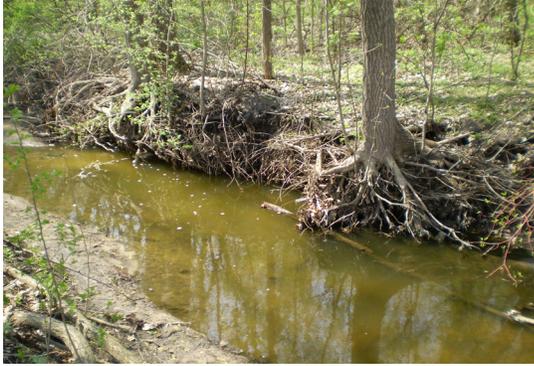
## Photo of Streambank Erosion

City: Middleton, WI  
 Watercourse: Lake View Park Drainage Swale  
 Location ID Number: 4  
 Location: Approximately 150' Downstream of Outlet  
 Date Sampled: 5/1/2008

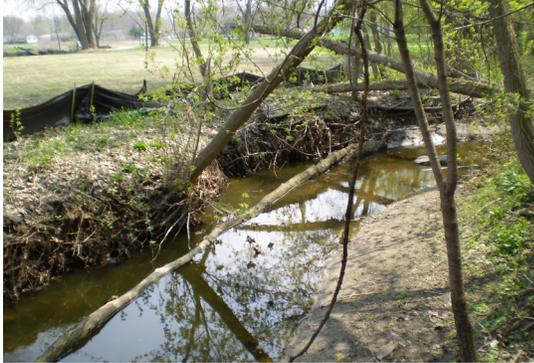
## Photo of Streambank Erosion

City: Middleton, WI  
 Watercourse: Lake View Park Drainage Swale  
 Location ID Number: 5  
 Location: Approximately 200' Downstream of Outlet  
 Date Sampled: 5/1/2008

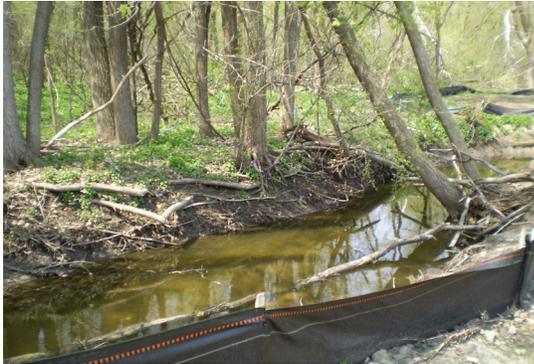
## Photo of Streambank Erosion

City: Middleton, WI  
 Watercourse: Lake View Park Drainage Swale  
 Location ID Number: 6  
 Location: Approximately 240' Downstream of Outlet  
 Date Sampled: 5/1/2008

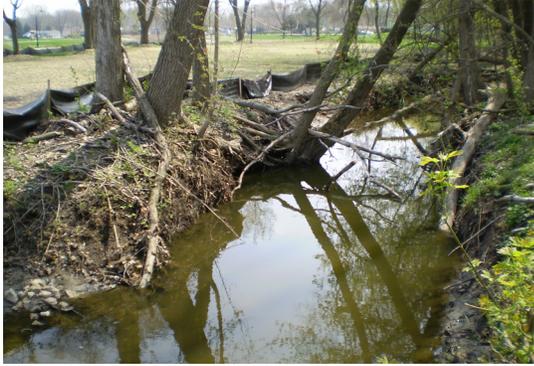
## Photo of Streambank Erosion

City: Middleton, WI  
 Watercourse: Lake View Park Drainage Swale  
 Location ID Number: 7  
 Location: Approximately 240' Downstream of Outlet  
 Date Sampled: 5/1/2008

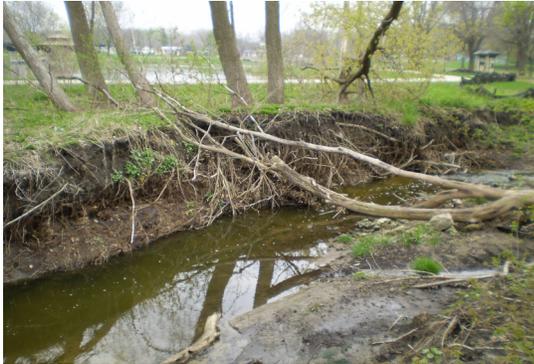
## Photo of Streambank Erosion

City: Middleton, WI  
 Watercourse: Lake View Park Drainage Swale  
 Location ID Number: 8  
 Location: Approximately 165' Upstream Walking Bridge  
 Date Sampled: 5/1/2008

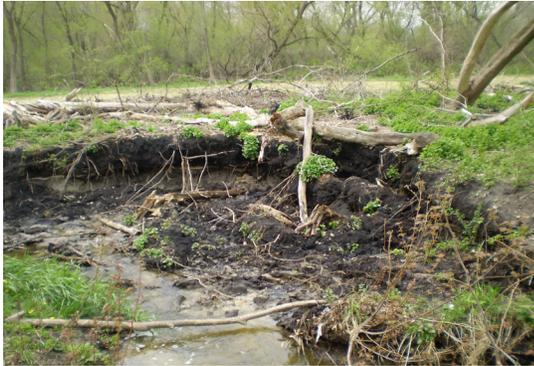
Photo of Streambank Erosion

City: Middleton, WI  
 Watercourse: Lake View Park Drainage Swale  
 Location ID Number: 9  
 Location: Approximately 140' Upstream Walking Bridge  
 Date Sampled: 5/1/2008

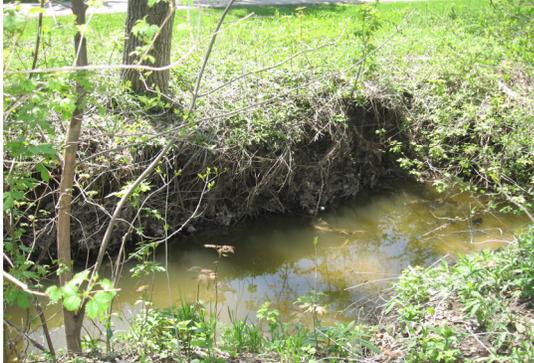
Photo of Streambank Erosion

City: Middleton, WI  
 Watercourse: Lake View Park Drainage Swale  
 Location ID Number: 10  
 Location: Approximately 80 feet upstream of walking bridge  
 Date Sampled: 5/1/2008

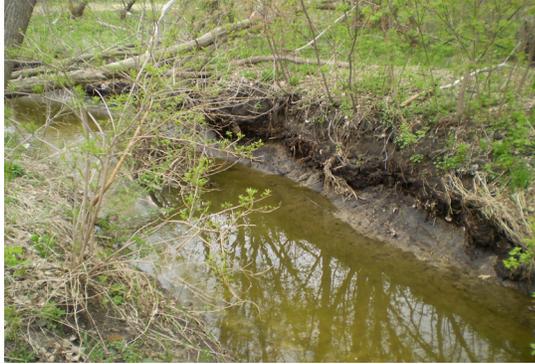
## Photo of Streambank Erosion

City: Middleton, WI  
 Watercourse: Lake View Park Drainage Swale  
 Location ID Number: 11  
 Location: Approximately 80 feet upstream of walking bridge  
 Date Sampled: 5/1/2008

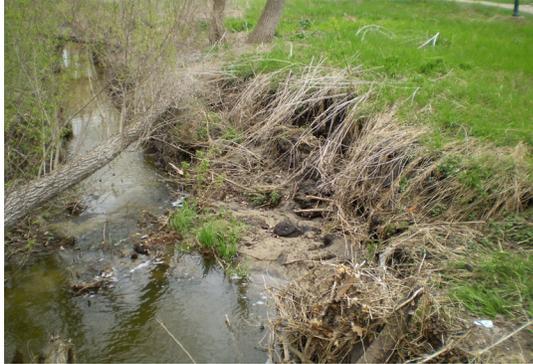
Photo of Streambank Erosion

City: Middleton, WI  
 Watercourse: Lake View Park Drainage Swale  
 Location ID Number: 12  
 Location: Approximately 40' Downstream of Walking Bridge  
 Date Sampled: 5/1/2008

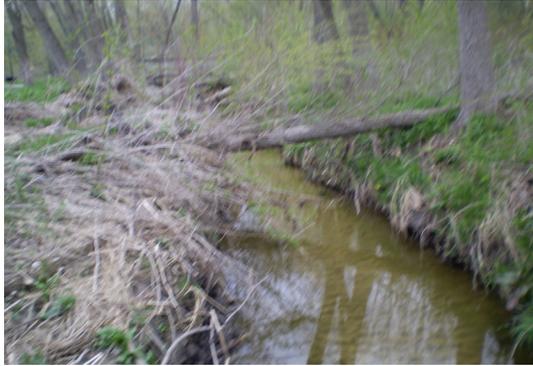
Photo of Streambank Erosion

City: Middleton, WI  
 Watercourse: Lake View Park Drainage Swale  
 Location ID Number: 13  
 Location: Approximately 100' Downstream of Walking Bridge  
 Date Sampled: 5/1/2008

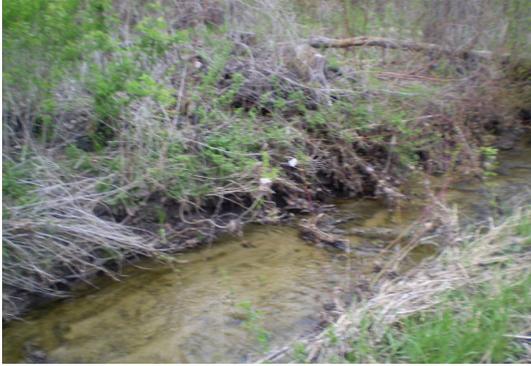
## Photo of Streambank Erosion

City: Middleton, WI  
 Watercourse: Lake View Park Drainage Swale  
 Location ID Number: 14  
 Location: Approximately 130' Downstream of Walking Bridge  
 Date Sampled: 5/1/2008

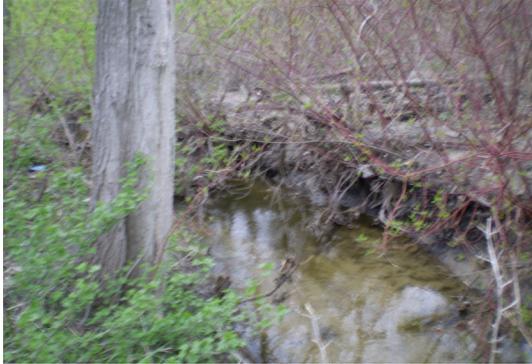
## Photo of Streambank Erosion

City: Middleton, WI  
 Watercourse: Lake View Park Drainage Swale  
 Location ID Number: 15  
 Location: Approximately 340' Downstream of Walking Bridge  
 Date Sampled: 5/1/2008

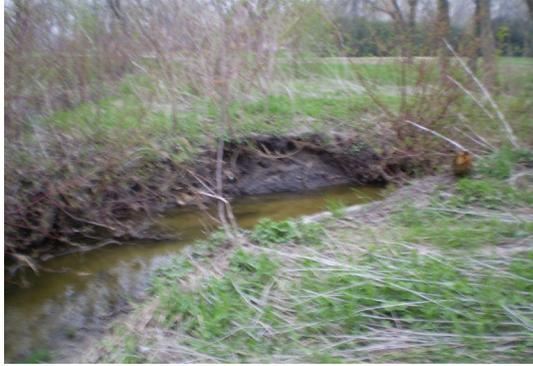
## Photo of Streambank Erosion

City: Middleton, WI  
 Watercourse: Lake View Park Drainage Swale  
 Location ID Number: 16  
 Location: Approximately 425' Downstream of Walking Bridge  
 Date Sampled: 5/1/2008

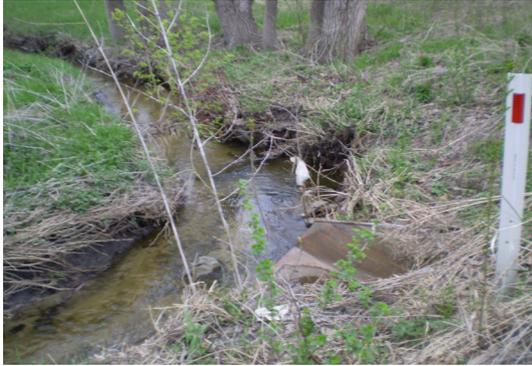
## Photo of Streambank Erosion

City: Middleton, WI  
 Watercourse: Lake View Park Drainage Swale  
 Location ID Number: 17  
 Location: Approximately 475' Downstream of Walking Bridge  
 Date Sampled: 5/1/2008

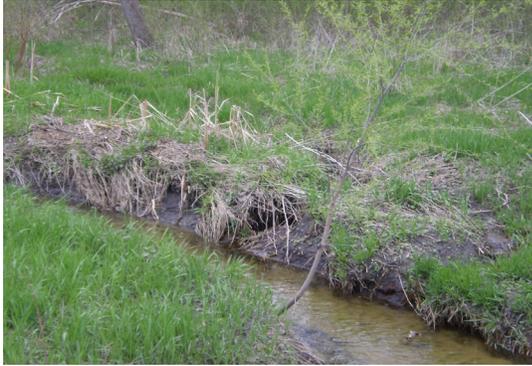
## Photo of Streambank Erosion

City: Middleton, WI  
 Watercourse: Lake View Park Drainage Swale  
 Location ID Number: 18  
 Location: Approximately 40' Upstream of Culvert under Allen Blvd.  
 Date Sampled: 5/1/2008

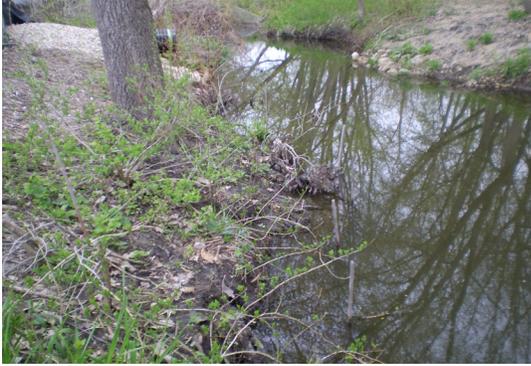
Photo of Streambank Erosion

City: Middleton, WI  
 Watercourse: Lake View Park Drainage Swale  
 Location ID Number: 19  
 Location: Approximately 230' East of Allen Blvd.  
 Date Sampled: 5/1/2008

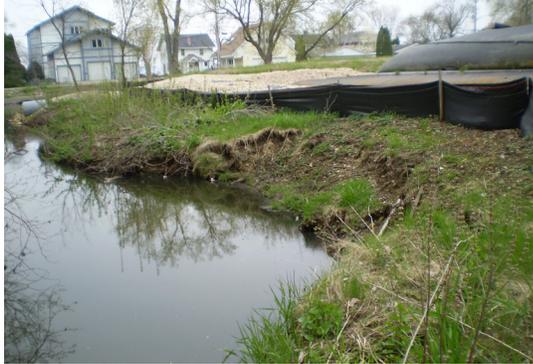
Photo of Streambank Erosion

City: Middleton, WI  
 Watercourse: Lake View Park Drainage Swale  
 Location ID Number: 20  
 Location: Approximately 280' East of Allen Blvd.  
 Date Sampled: 5/1/2008
