# Streambank Erosion Estimation

City: Middleton, WI  
 Watercourse: Lake View Park Drainage Swale  
 Location ID Number: 1  
 Location: Approximately 45' Downstream of Outlet  
 Date Sampled: 5/1/2008

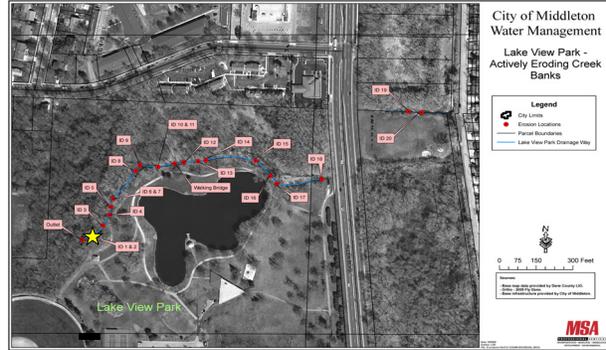
★ Location of Streambank Erosion

Parameter	
Stream Side (LEFT or Right)*	RIGHT
Length (ft)	90
Height (ft)	3
Lateral Recession Rate (ft/yr)**	0.2
Soil Unit Weight (lb/ft <sup>3</sup> )	90
Soil P Concentration (lb/lb soil)	
Stream Bank Erosion (tons/yr)	2.4
